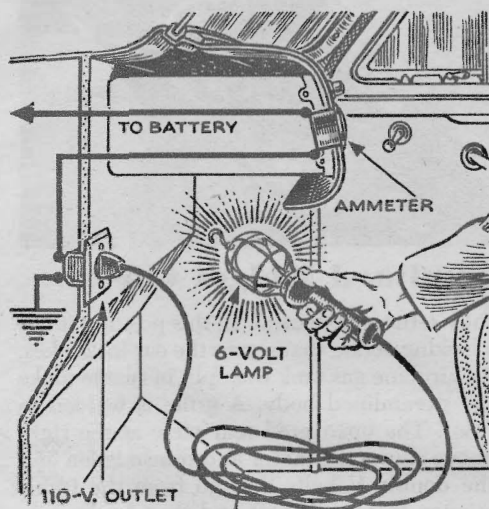
Trouble Light Doubles in Car.

One extension cord kept in the car is always available for use as a trouble light with the accessories added by W. M. Dierks, of Chicago. He installed a standard 110-volt outlet in the car, wiring it from the ammeter to ground. At the other end is a 6-volt bulb with a standard screw base. For use on house current it is only necessary to replace the bulb with a 110-volt one.

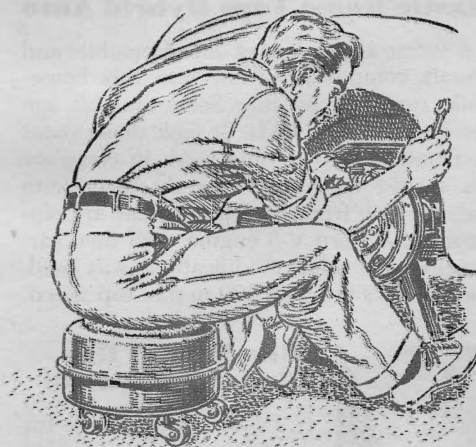
Stool Built of Brake Drums. One mechanic made his job easier by welding two discarded brake drums together. Four casters on the bottom and a sheepskin buffing pad on top make it a serviceable rolling stool. It's particularly good for jobs for which you'd ordinarily have to kneel.
